CASE STUDY

Location: Glenmore Water Treatment Plant - City of Calgary, Canada

Application: Pipe Gallery Walkway Expansion

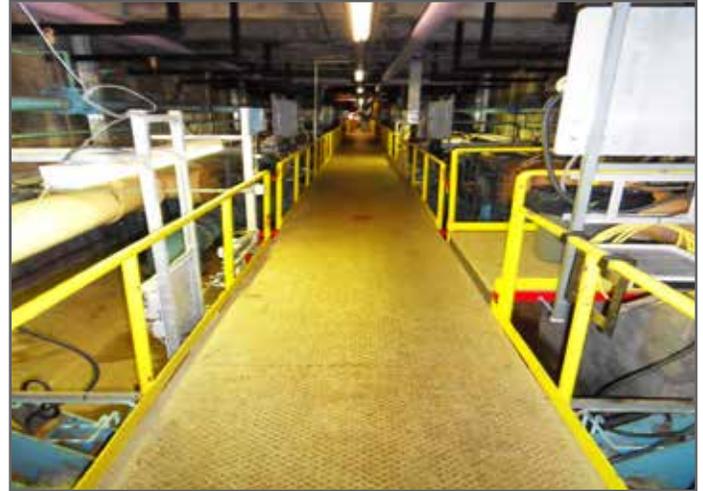
Before

The Glenmore Water Treatment Plant required upgrades for their narrow walkway in the pipe gallery as their existing one consisted of steel gratings that were far too narrow for the upgrades and had become rusty and slippery which was a health and safety hazard. The customer was also looking to install an additional staircase in the north end of the building as a secondary entrance/exit.

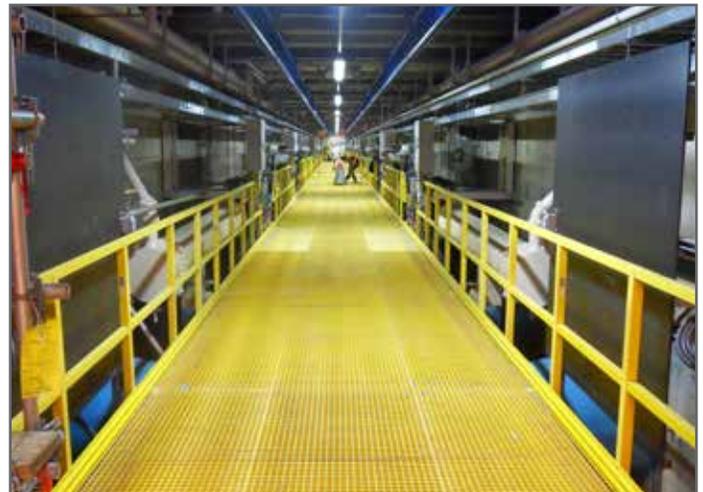
After

The pipe gallery walkway expansion was constructed of Fibergrate Molded Grating and Dynaform Structural Shapes to replace the existing steel, therefore, providing a slip resistant surface for the workers. Dynarail® NSF-61 handrails, ladders and self-closing gates designed for portable water applications were also installed in the filter bed gallery. An additional FRP staircase was designed and fabricated for the building exterior, complete with handrail that have additional UV protection, in order to provide access to the rooftop.
